Protective properties of a multi-layer external coating applied to underground pipes of ductile iron

AGNIESZKA KOCHMAŃSKA, ANNA WASSILKOWSKA, WOJCIECH DĄBROWSKI

DOI 10.36119/15.2020.8.5

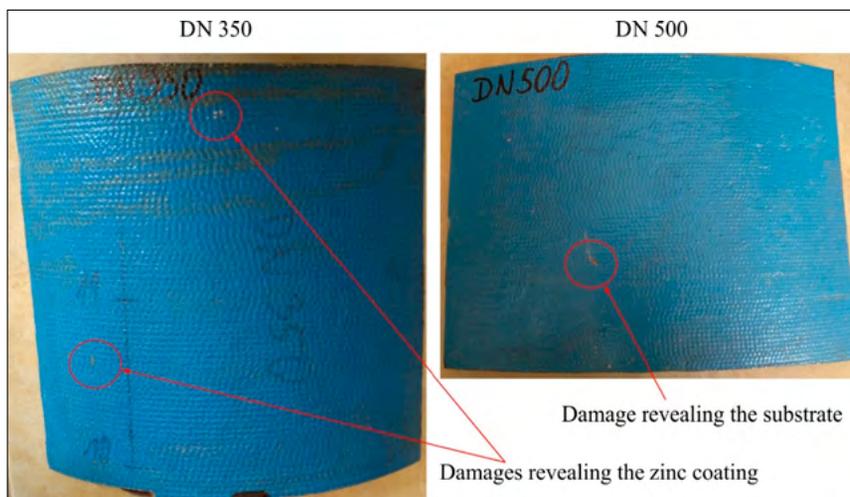
samples were visually examined for potential damages in the coating (Fig. 2).

Fig. 2.
Images of the material cut from the pipes with diameter of 350 mm and 500 mm
Ryc. 2. Zdjęcia materiału wyciętego z rur o średnicy 350 mm i 500 mm

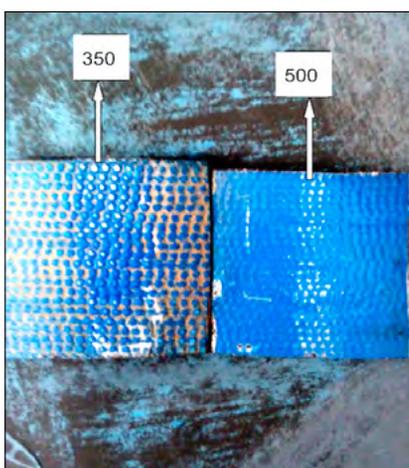
Abrasion test was performed manually using a grinding paper of gradation 1000# (grain size 4.5+1mm) in a plane tangential to the pipe external surface. The pipe outer surface showed a regular wave pattern associated with the casting process (Fig. 3 and Fig. 4). Thus the abrasion might lead to many regular "spots", each containing images of layer-by-layer external coating components: sealing paint, thermally sprayed Zn-Al, ferric oxides covering the surface of the ductile iron pipe and finally the iron pipe itself. Visual inspection of the grinding paper reveals different colored residues coming from the scraped outer coating: a blue color for the pipe DN 350 (Fig 3 left) and a gray one for the pipe

Fig. 3.
Images of samples abrasion using paper of 1000#. Blue sediment for the pipe DN 350 and gray sediment for DN 500, respectively.
Ryc. 3. Widok próbek ścieranych na papierze o gradacji 1000#. Niebieski osad dla rury DN 350 i szary osad odpowiednio dla rury DN 500.

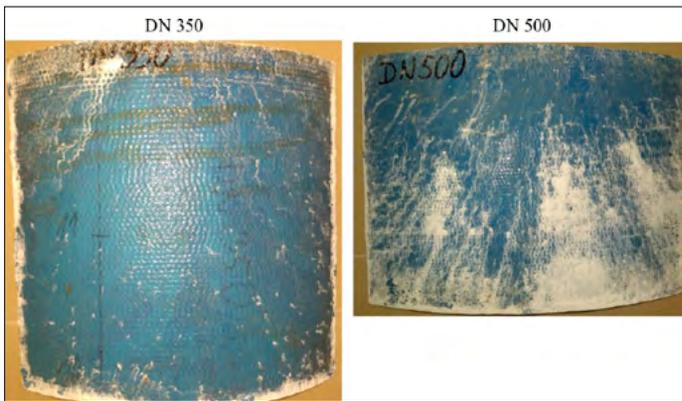
The photographs of the samples after the salt spray test are presented in Fig. 5. After 100 hours of the test three areas with red corrosion (corrosion products of cast iron substrate) were noticed on the pipe sample DN 350. Two of these spots matched the damages observed before the test. The areas with red corrosion spots did not increase throughout the test. The first symptom of white corrosion (the corrosion product of the metallic coating) was spotted only at one point (at the upper edge) after 200 hours of the test. Except this single point, no other changes related to the corrosion of the zinc coating were noticed for next 700 hours of the test. After 1000 hours in the salt chamber, the sample DN 350 looked much better than the sample from the pipe DN500.

In case of the sample DN 500, the first symptoms of white corrosion were observed after 100 hours of the test. After this time, two areas with red corrosion were found; one of them matched the dam-

Fig. 5. The samples after 1000 hours of the salt spray test.
Ryc. 5. Próbkę po 1000 godzinach testu w mgłę solnej.

age of the coating observed before the test. After each subsequent stage of the test, the other areas with corrosion products of the metallic coating (white corrosion) were observed. It proves a low quality of the paint coating.

The coated surface, except for the edges, was evaluated according to the Standard [5] for the paint coating evaluation. Assessment of the degree of rusting was presented in Table 1. The degree of rusting shown in this table refers to both white corrosion (corrosion products of the zinc coating) and red corrosion (corrosion products of the cast iron substrate). The analysis of the zinc coating performance during NNS shows significant differences between the quality of the samples' surfaces (Tab. 2).

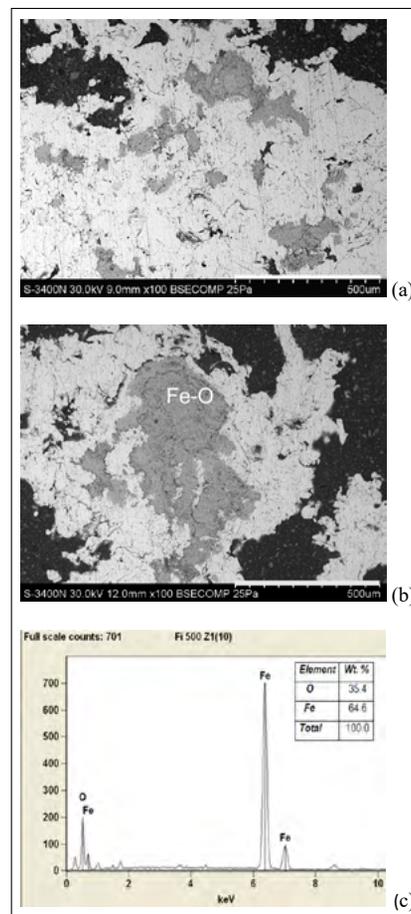
Fig. 6. Microstructure observed on flat spot-sections using the SEM microscope: a, b) two different "spots" of the sample DN500; c) EDS analysis of the ferric oxide area (magnification bar of 0.5 mm)
Ryc. 6. Mikrostruktura zaobserwowana na płaskich przekrojach plamkowych za pomocą mikroskopu SEM: a, b) dwa różne „punkty” próbki DN500; c) Analiza EDS obszaru tlenku żelaza (pasek powiększenia 0,5 mm)

oxides are continuously surrounded by the Zinalium protective layer (Fig. 6 a,b). The EDS analyze indicates that the visible oxide spot contains exclusively iron and oxygen. This means that the uncovered layer of ferric oxides is external, as the lower layer always contains silica in the concentration between 3-7 wt. % [4].

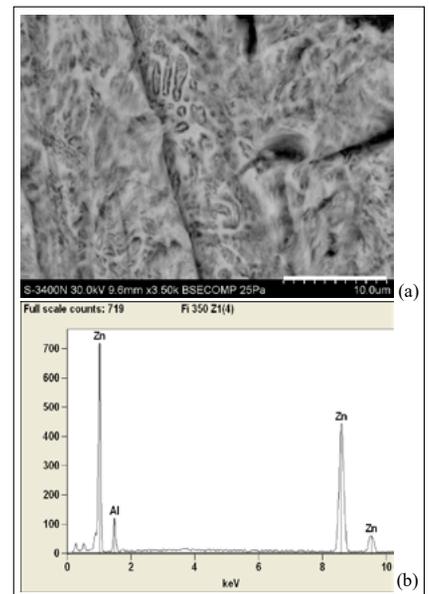
Fig. 7. Microstructure of the Zn-Al coating: a) flat section of the sample DN500 (magnification scale of 10 mm), b) EDS analysis of the coating
Ryc. 7. Mikrostruktura powłoki Zn-Al: a) płaski przekrój próbki DN500 (skala powiększenia 10 mm), b) Analiza powłoki EDS

In Figure 7 a fragment of Zn-Al alloy is presented and zinc and aluminium grains can be easily recognized. As it is known, this alloy contains micro-pores created during thermal spraying. According to [9], the pores size is in the range of 2.5 to 10 µm. The zinc coating mass cannot be calculated from the cross section of a pipe wall because of the pores, as presented in Figure 7. Other electrolytical methods can be applied for this purpose. The coating consists of lamellas of the thickness from 10 to 15 micrometers (Fig. 7).

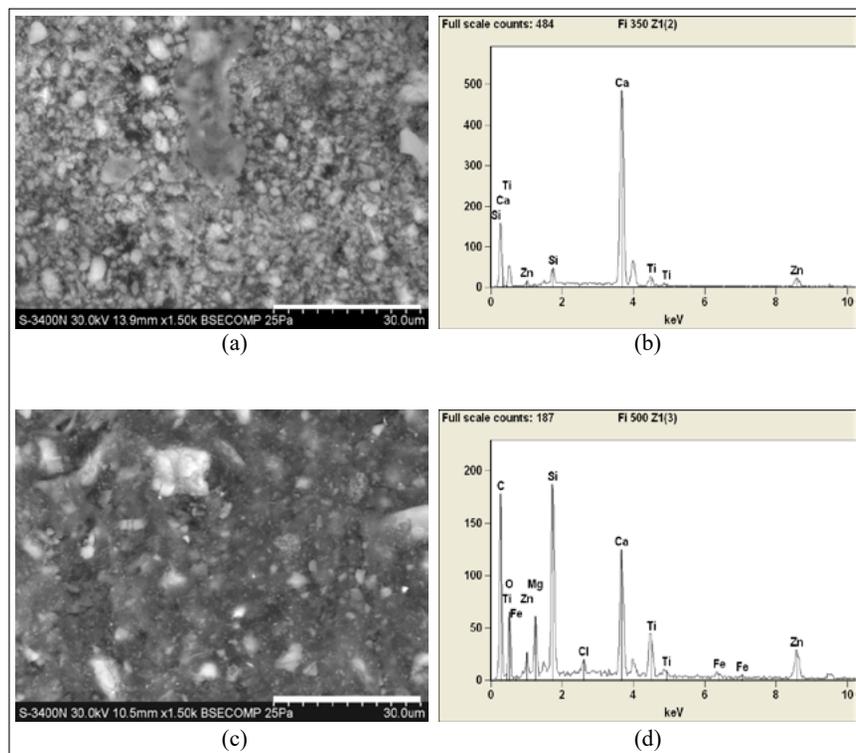
The EDS analysis of two paint coatings applied by two producers to protect the pipes DN 350 and DN 500 are presented in Fig. 8. The paint (A) that gives much better protection to the Zinalium coating contains high concentrations of Ca and Zn, as presented in Table 3 and in the form of X-ray peaks (Fig. 8b).

The EDS analyze does not apply to the five elements of the lowest number of protons and usually overestimates the carbon concentration (Tab. 3). The composition of the less protective paint (B) is significantly different. The paint comprises mostly carbon and traces of other elements: Si, Zn, Ti and Mg.

Fig. 8. Paints morphology and a chemical composition: a) the sample DN 350, b) the respective EDS analysis, c) the sample DN500, d) the respective EDS analysis (magnification scale of 30 mm)
Ryc. 8. Morfologia farb i skład chemiczny: a) próbka DN 350, b) odpowiednia analiza EDS, c) próbka DN500, d) odpowiednia analiza EDS (skala powiększenia 30 mm)
