# Crevice corrosion at welded spacers of stainless steel double pipeline. Case study

JAN MARJANOWSKI

Pipe in pipe (PIP) constructed from DIN 1.4301/1.4307 stainless steel was used for neutral product (chocolate) transport at 58°C in a food plant. Stainless steel spacers were welded along the internal pipeline. Corrosion rate increased because iron ions dissolved and dispersed in water were introduced to the outer stainless steel pipeline from carbon steel installation and carbon steel buffer tank. Rust patches were formed in all pockets present in the pipeline jacket because of iron ions content in water. Local chlorides concentration increased due to adsorption in rust so that crevice and pitting effects were very high. Heating water circulating between external and internal pipeline effected high number perforations of both lines in 20 days after production started. Perforations were localised mainly in crevices present between stainless steel spacers and both pipelines. Preventive measures against corrosion were suggested.

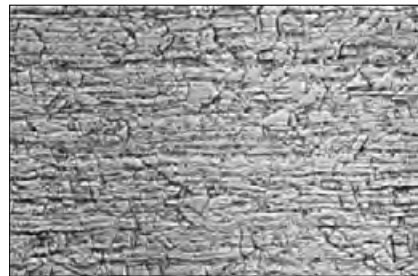
The micro-structure of the stainless steel used to construct the pipelines show high content of linear  $\delta$ -ferrite in the structure (Fig. 1-2). The existing structure was probably the result of improper cooling rate of stainless steel treatment in the mill. Austen-

**Fig. 1. Stainless steel austenite structure with  $\delta$ -ferrite inclusions**

ite mixed with  $\delta$ -ferrite inclusion does not have such good corrosion resistance like pure austenitic structure [4].

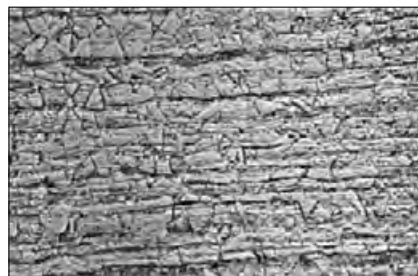
**Fig. 2. Stainless steel austenite structure with high number of  $\delta$ -ferrite inclusions<sup>7</sup>**

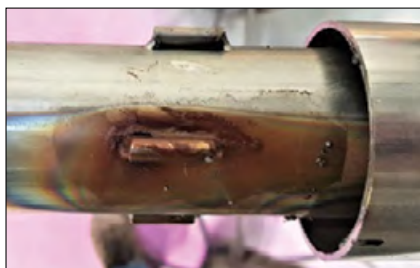
**Fig. 3.** The spacer at the side rusted at its bottom and its upper surface  
*Rys. 3. Boczny element dystansowy pokryty rdzą pomiędzy spoinami oraz na całej powierzchni*

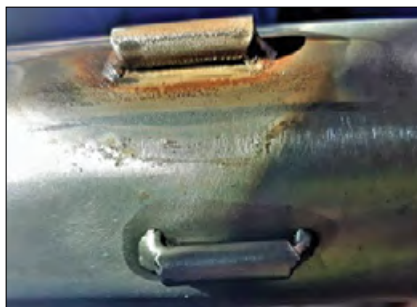
**Fig. 4.** Rusted and clean spacers after 20 days of hot water flow in the installation  
*Rys. 4. Zardzewiały oraz czysty, metaliczny element dystansowy po 20 dniach przepływu gorącej wody w instalacji*

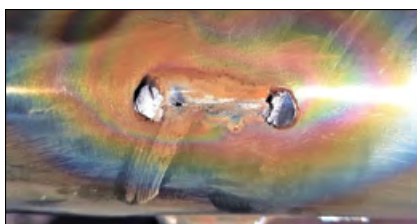
**Fig. 6**

**Fig. 6-8.** Stainless steel pipeline surface after removal of the spacers. Pits or crevice were present within bright surface (corrosion couple anode)  
*Rys. 6-8. Powierzchnia rurociągu ze stali nierdzewnej po usunięciu elementu dystansowego*
