Application of infrared thermography measurements in thermal diagnostics of the swimming pool

Wykorzystanie badań termowizyjnych do diagnostyki cieplnej hali pływalni

PIOTR CIUMAN

DOI 10.36119/15.2020.5.4

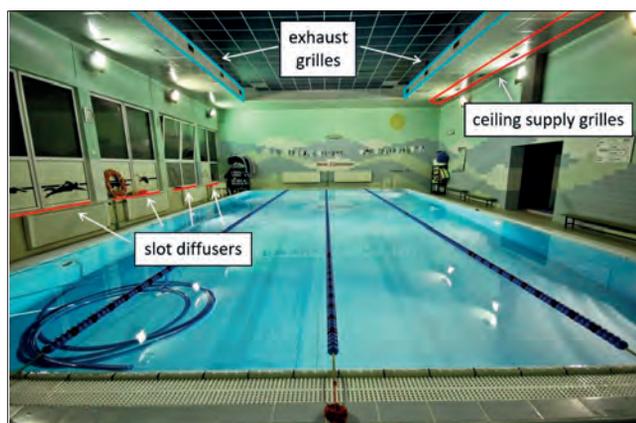
Fig. 1. View of the interior of the school's swimming pool [21]
Rys. 1. Widok wnętrza badanej hali szkolnej pływalni [21]

Fig. 1 shows the interior of the examined swimming pool. The location of ceiling supply grilles, slot diffusers and exhaust grilles is marked on it. Fig. 2 shows the arrangement of O1-O6 windows in the south-western wall, K1-K7 ceiling supply grilles and N1-N12 slot diffusers.

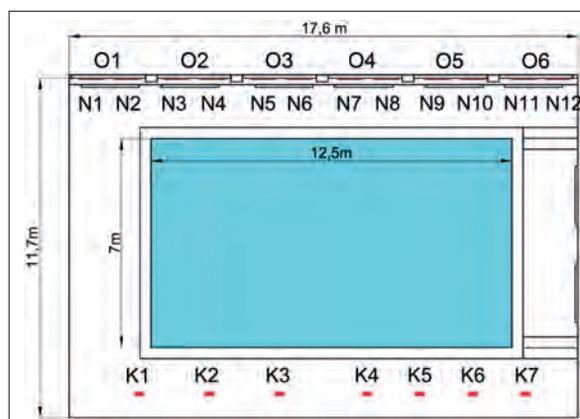
Fig. 2. Arrangement of ceiling supply grilles, slot diffusers and windows in the swimming pool [2]
Rys. 2. Rozmieszczenie okien oraz nawiewników sufitowych i szczelinowych w hali pływalni [2]

faces of selected two windows O3 and O5 (Fig. 2). In order to detect areas at risk of moisture condensation, a dew point alarm was applied in FLIR Tools (right side of Fig. 7). This is the area marked green on the thermogram, whose temperature is lower than 17.9°C . On the thermograms made for all O1-O6 windows, measurement areas were introduced to determine the average temperature of the windows. Average temperature values ranged from 19.6°C to 25.3°C .

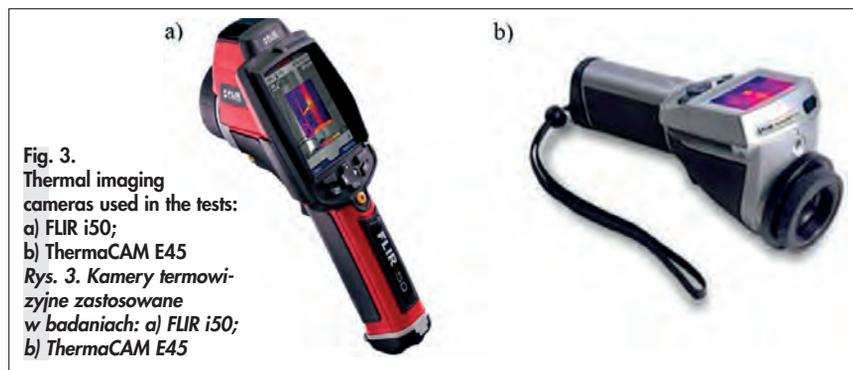
Fig. 3. Thermal imaging cameras used in the tests: a) FLIR i50; b) ThermaCAM E45
Rys. 3. Kamery termowizyjne zastosowane w badaniach: a) FLIR i50; b) ThermaCAM E45

The measurements were carried out with FLIR i50 and ThermaCAM E45 thermal imaging cameras (Fig. 3). Table 1 shows the basic parameters of the thermal imaging cameras used.

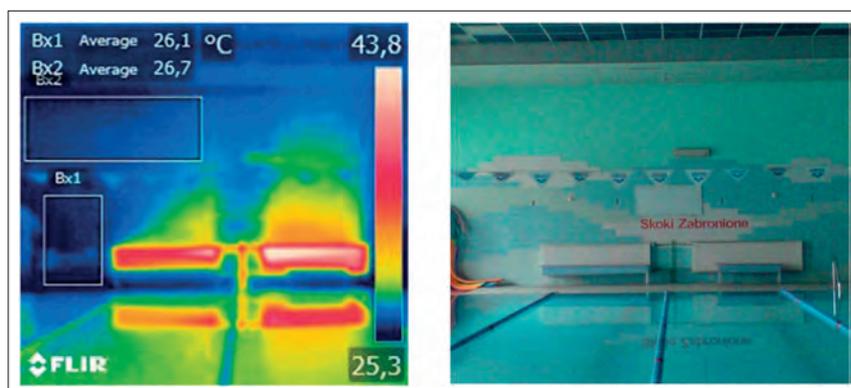
Fig. 4. Thermogram of the internal surface of the north-western external wall (left) and a photo of the partition (right) [2]

Fig. 4 shows the thermogram of the internal surface of the north-western external wall. Two measurement areas were applied in order to determine the temperature of that part of the partition which was not influenced by the radiators. The average temperature of the internal surface of the partition was 26.4°C.

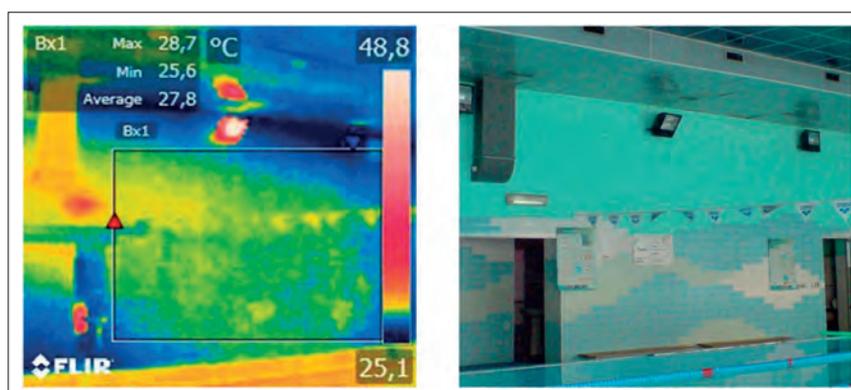
Fig. 5. Thermogram of the surface of the internal north-eastern wall (left) and a photo of the partition (right) [2]

Another thermogram (Fig. 5) shows the internal north-eastern wall, bordering on the swimming pool locker rooms. A single measurement area was applied covering a significant part of the wall, excluding heated lighting lamps. The average temperature of the partition surface was 27.8°C.

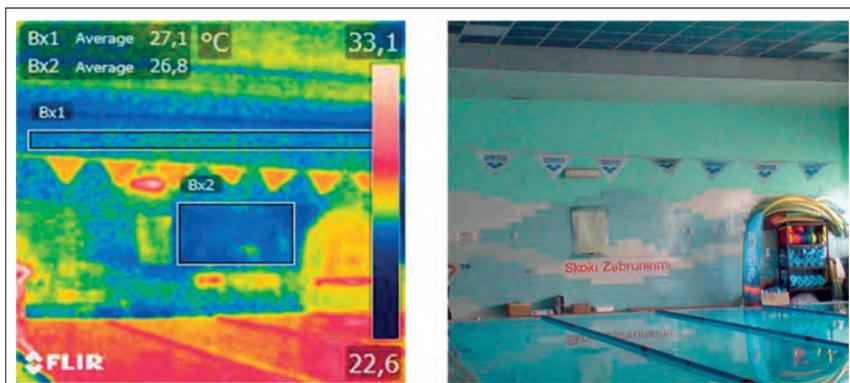
Fig. 6. Thermogram of the surface of the internal south-eastern wall (left) and a photo of the partition (right) [2]
Rys. 6. Termogram powierzchni ściany wewnętrznej południowo-wschodniej (po lewej) oraz zdjęcie przegrrody (po prawej) [2]

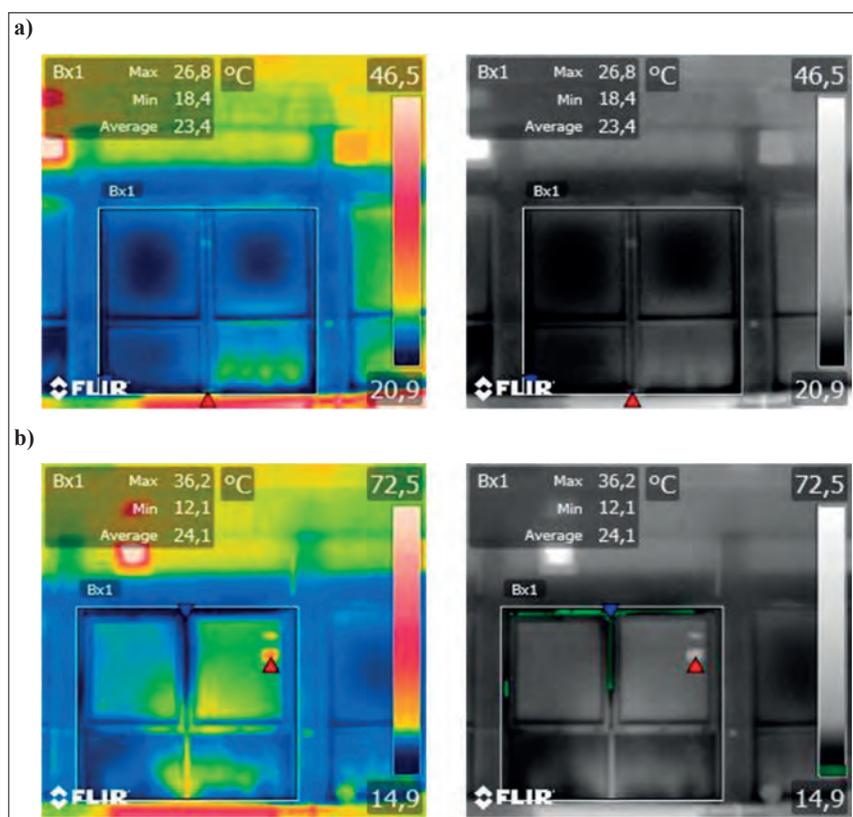
Fig. 7. Thermograms of windows surfaces before applying the air dew point alarm (left) and after applying the air dew point alarm (right): a) window O3, where no moisture condensation occurred, b) window O5, where areas of moisture condensation occurred [2]
Rys. 7. Termogramy powierzchni okien przed wprowadzaniem alarmu punktu rosy (po lewej) i po wprowadzeniu alarmu punktu rosy (po prawej): a) okno O3, na którym nie wystąpiło wykroplenie wilgoci, b) okno O5, na którym wystąpiły obszary wykroplenia wilgoci [2]

For most windows, the average temperature was similar, except for the O6 window, which had a temperature of 19.6°C . The reason for this was the turned-off radiator, located directly under the window, and the close vicinity of the second external wall. In case of all other windows, the radiators were on, which led to the increase of the windows temperature, as well as the external partition area. The average surface temperature values of the O1-O4 and O6 windows were higher than the dew point temperature, so there was no condensation at their entire surface. Only in case of the O5 window (Fig. 7b), there were areas where the temperature fell below the dew point and thus

the possibility of dampening the glass and the window frame appeared.

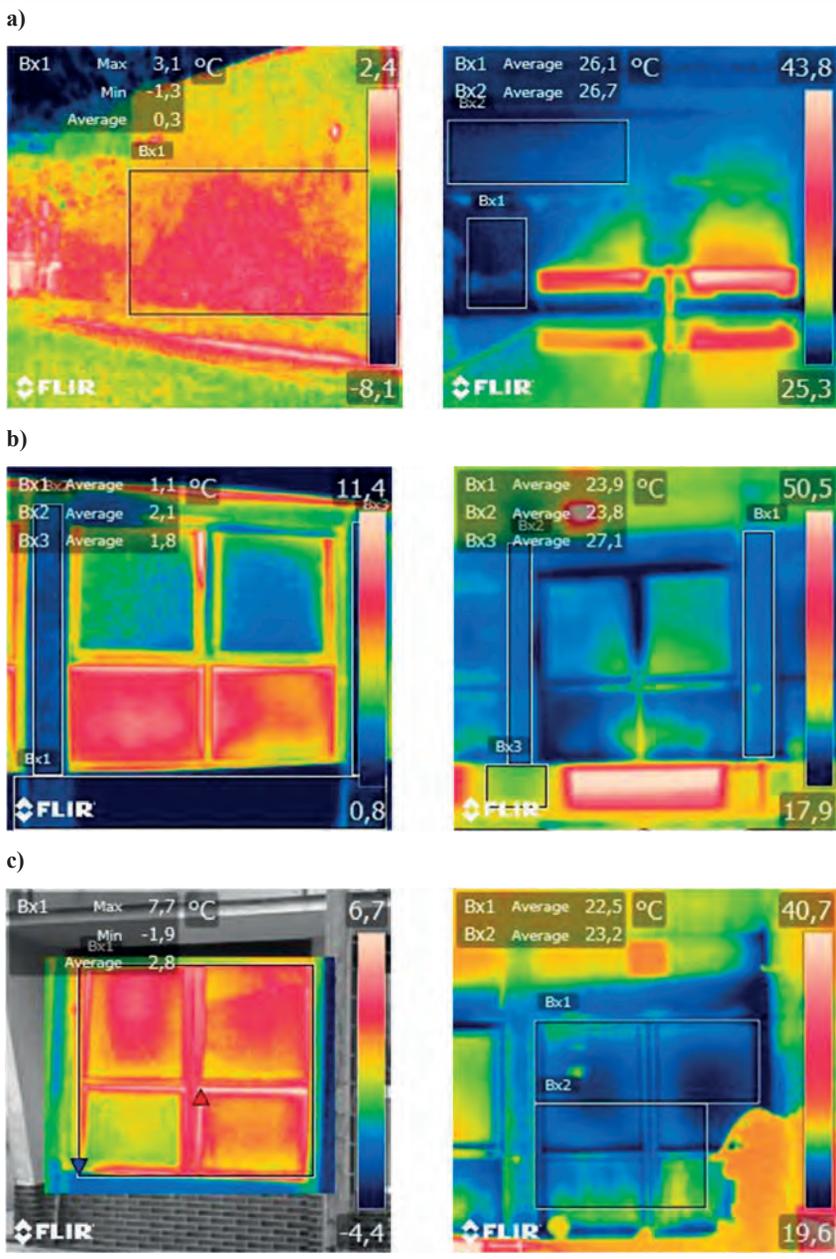
Fig. 8. Thermograms of external surface (left) and internal surface (right): a) north-western external wall, b) south-western external wall, c) windows in south-western wall [2]

The thermogram of the internal surface of the south-western external wall with windows is shown in Fig. 8b.

Thermovision measurements of temperature distribution on internal and external surfaces of tested building partitions were also used to determine thermal transmittance of those partitions, the values of which were necessary to determine boundary conditions for numerical simulations. Calculation of thermal transmittance was carried out for two external walls: north-western and south-western, as well as for a window in the south-western wall. Thermograms of the external and internal surfaces of the examined partitions are shown in Fig. 8.
